TECHNICAL REPORT GL-87-14

# SEISMIC STABILITY EVALUATION OF FOLSOM DAM AND RESERVOIR PROJECT

Report 2  
INTERFACE ZONES

David W. Sykora, Mary Ellen Hynes

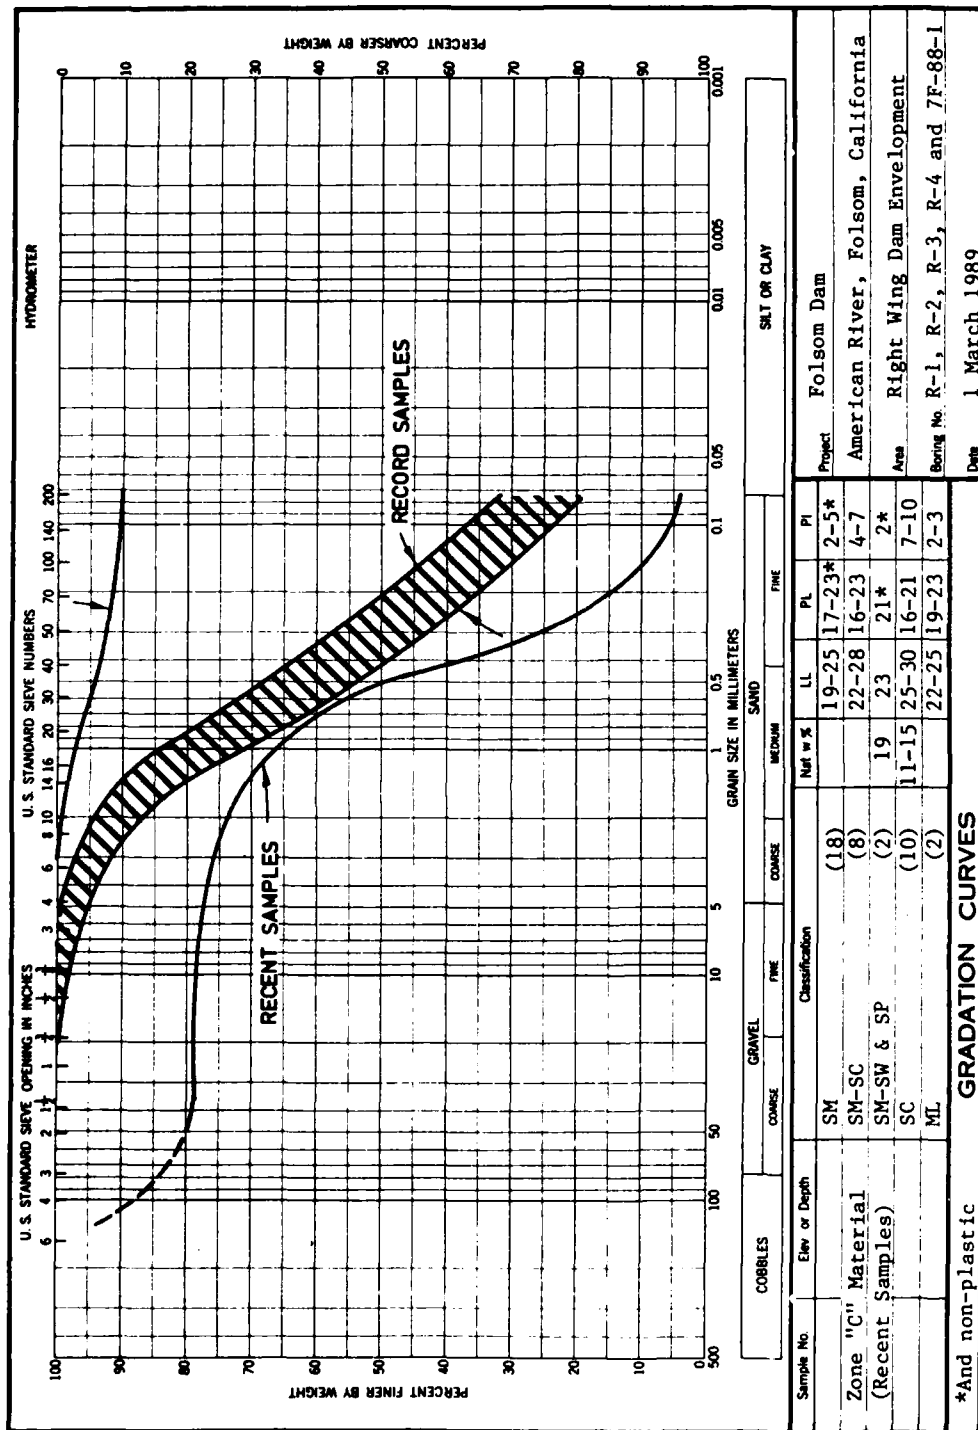
**Figure 50. Comparison of ranges in grain size distribution of core material at RWD interface zones**

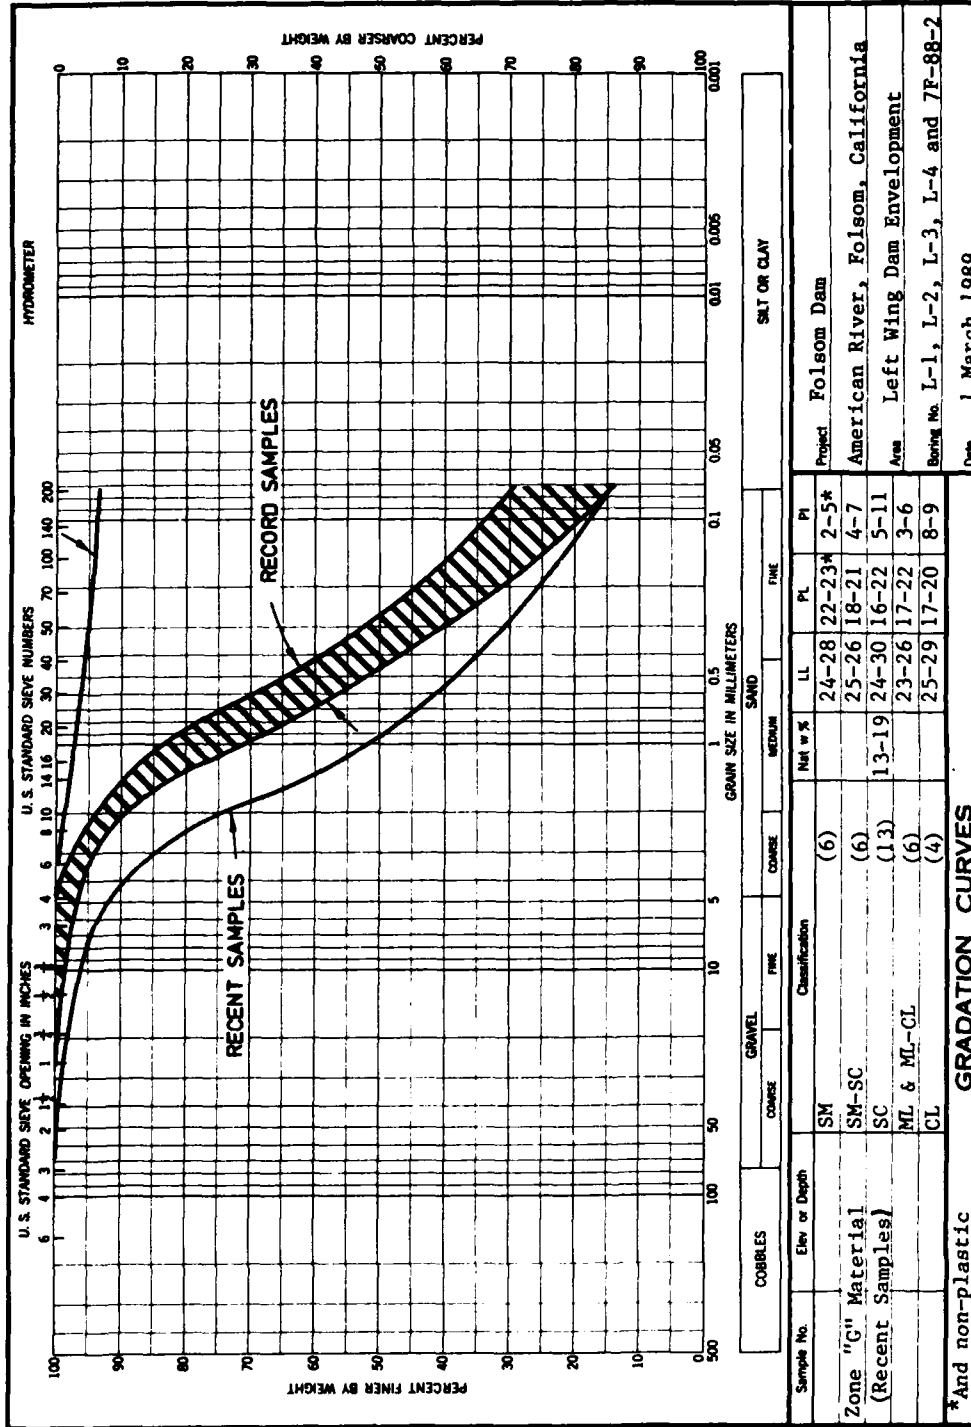
Figure 51. Comparison of ranges in grain size distribution of core material at LWD interface zones

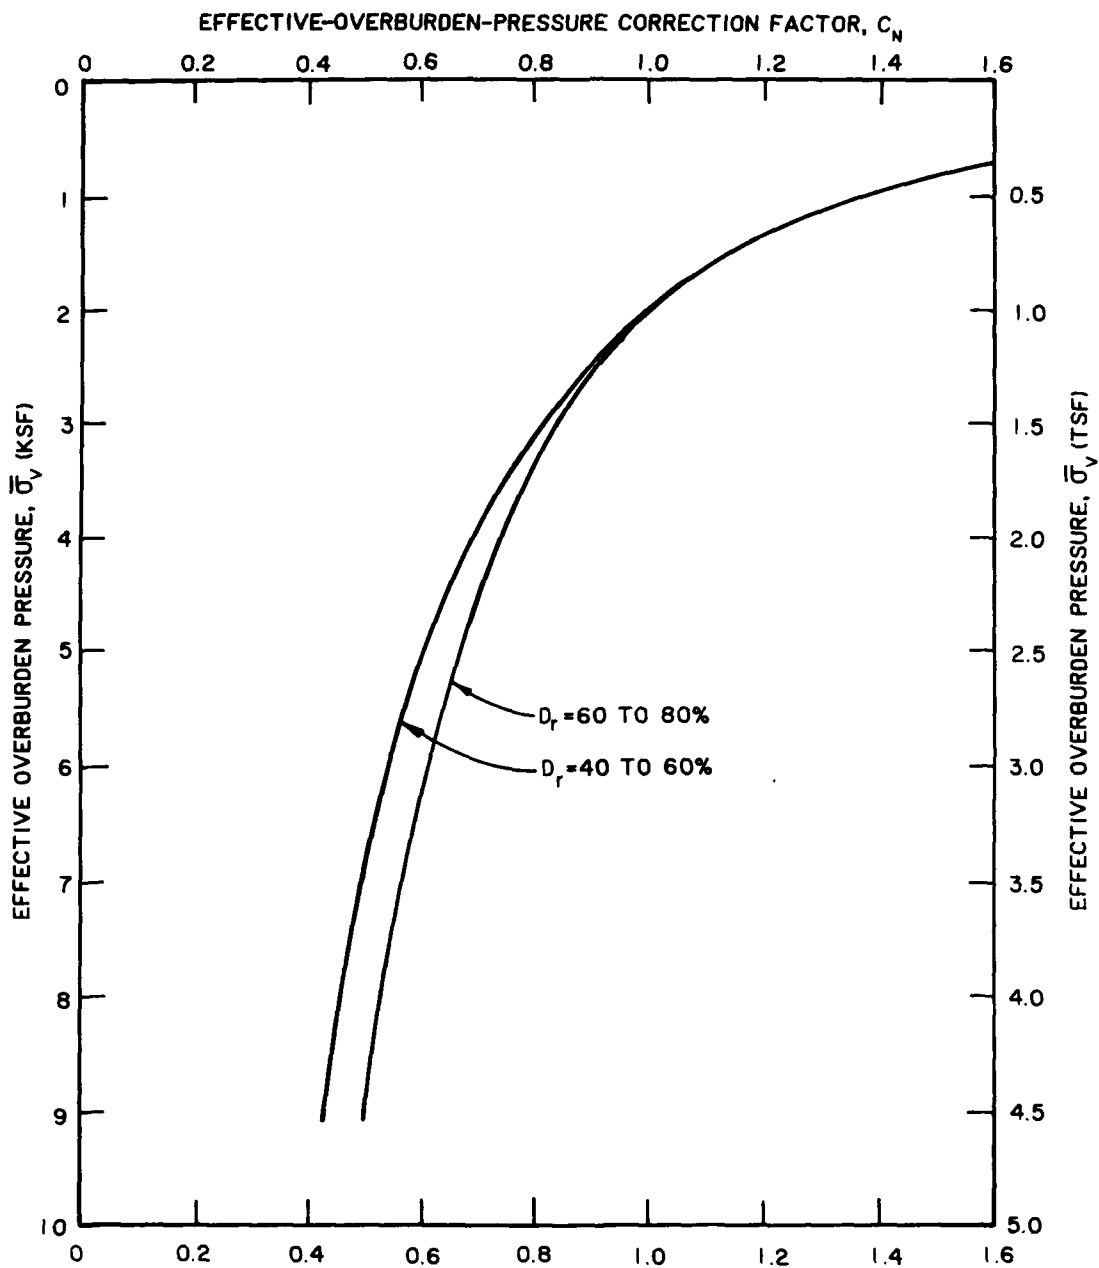
Figure 52. Empirical relations used to determine effective-overburden-pressure correction factors for SPT N or  $N_{60}$ -values

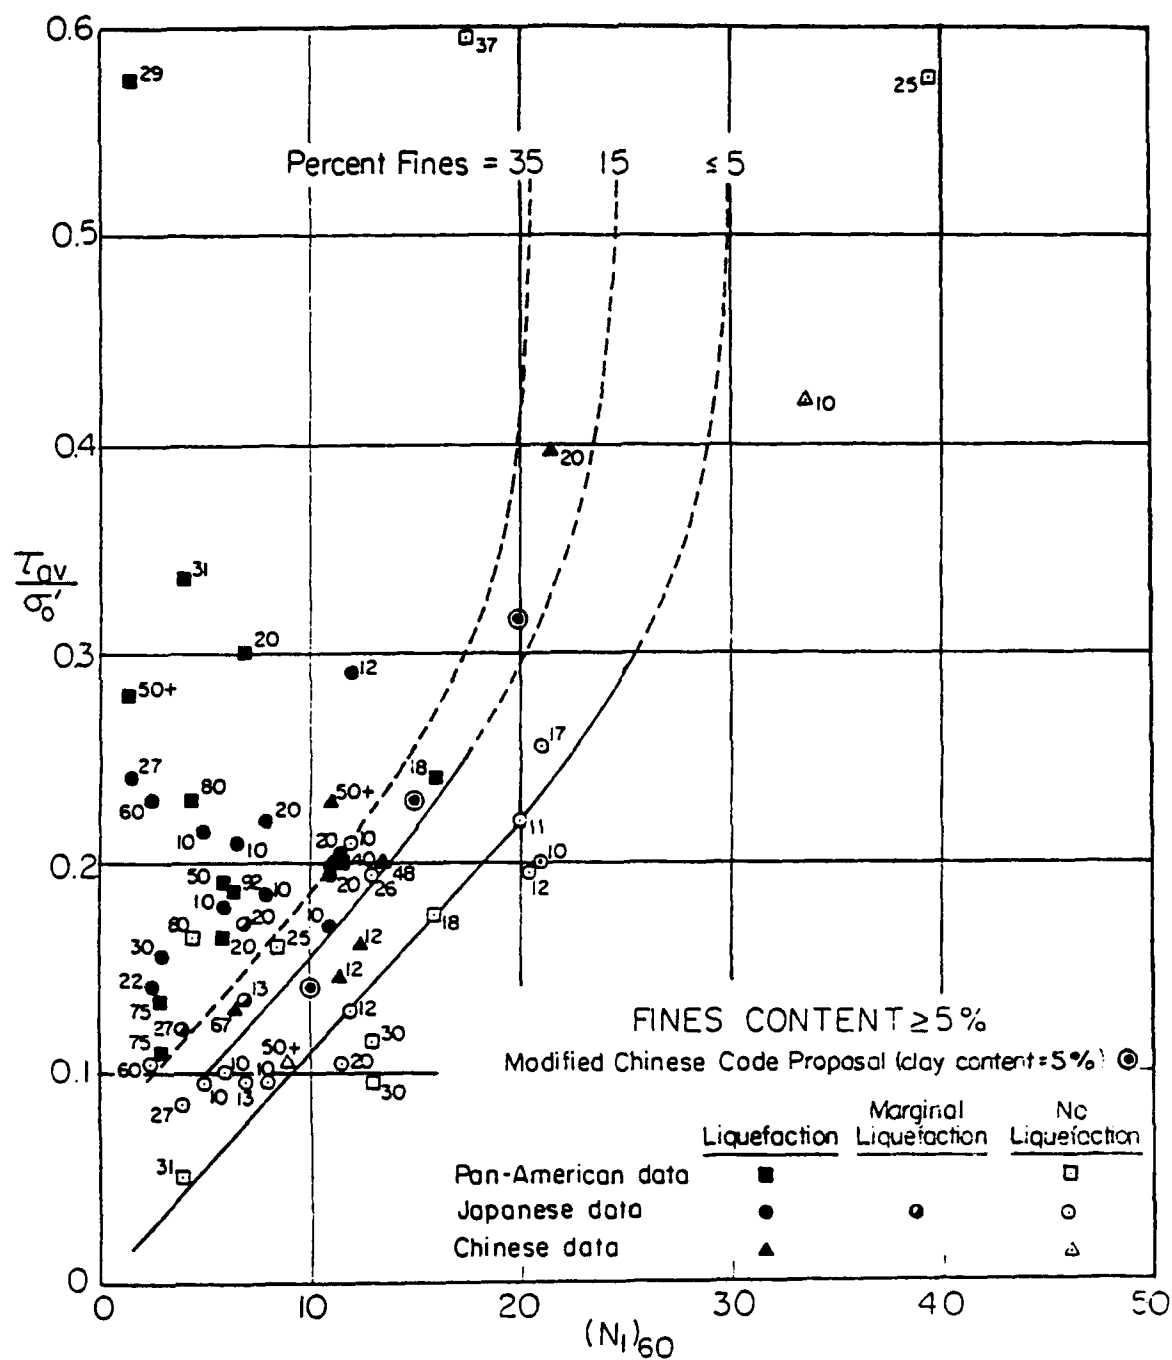
Figure 53. Relationships between stress ratio causing liquefaction and  $(N_1)_{60}$  -values for silty sands for  $M = 7\frac{1}{2}$  earthquakes (from Seed et al. 1985)

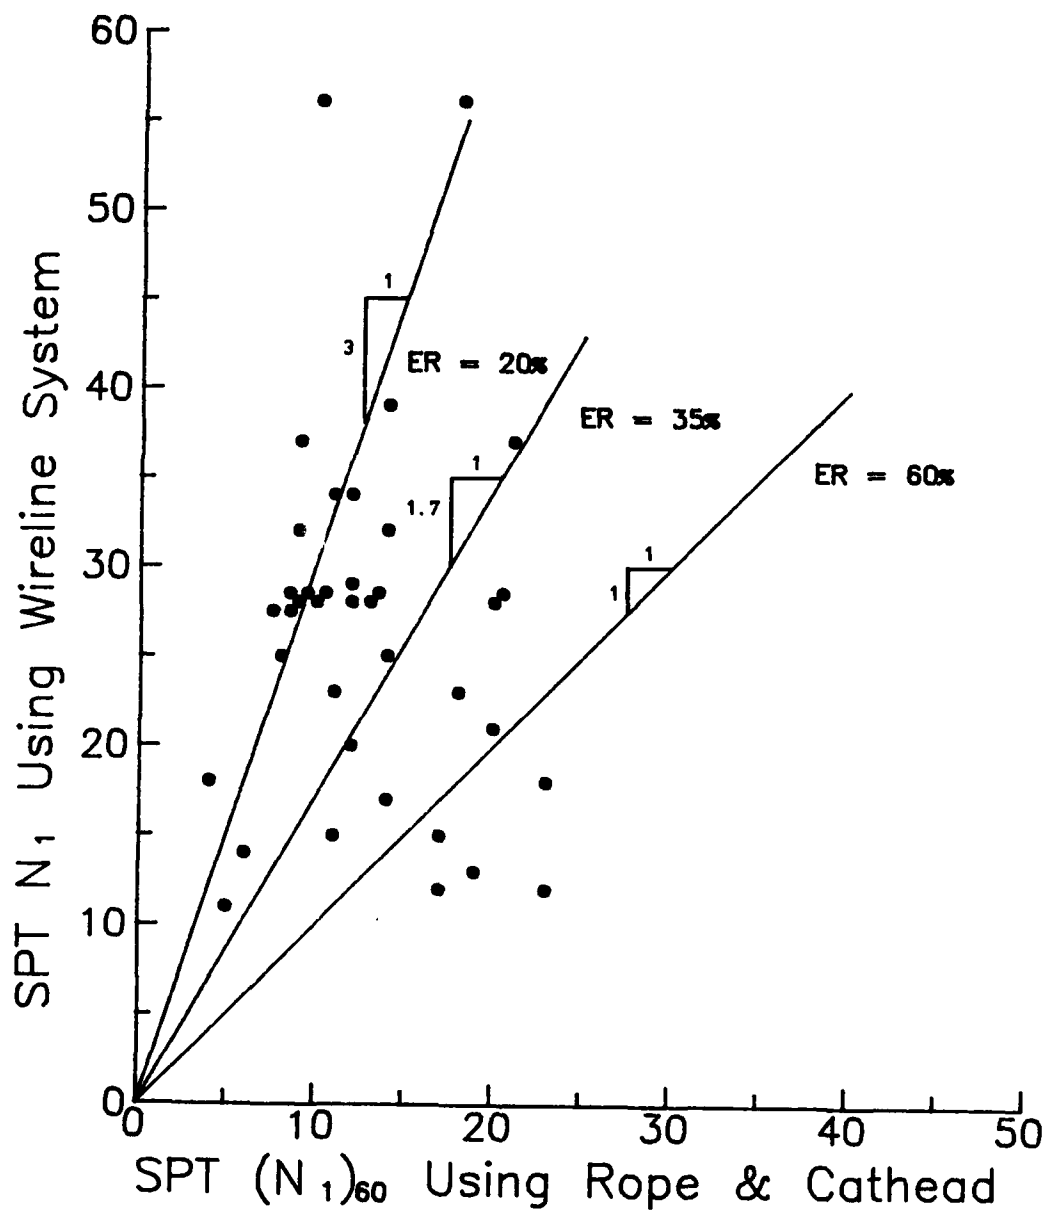
Figure 54. Comparison of blowcounts measured using rope-and-cathead and wireline systems at equal depths

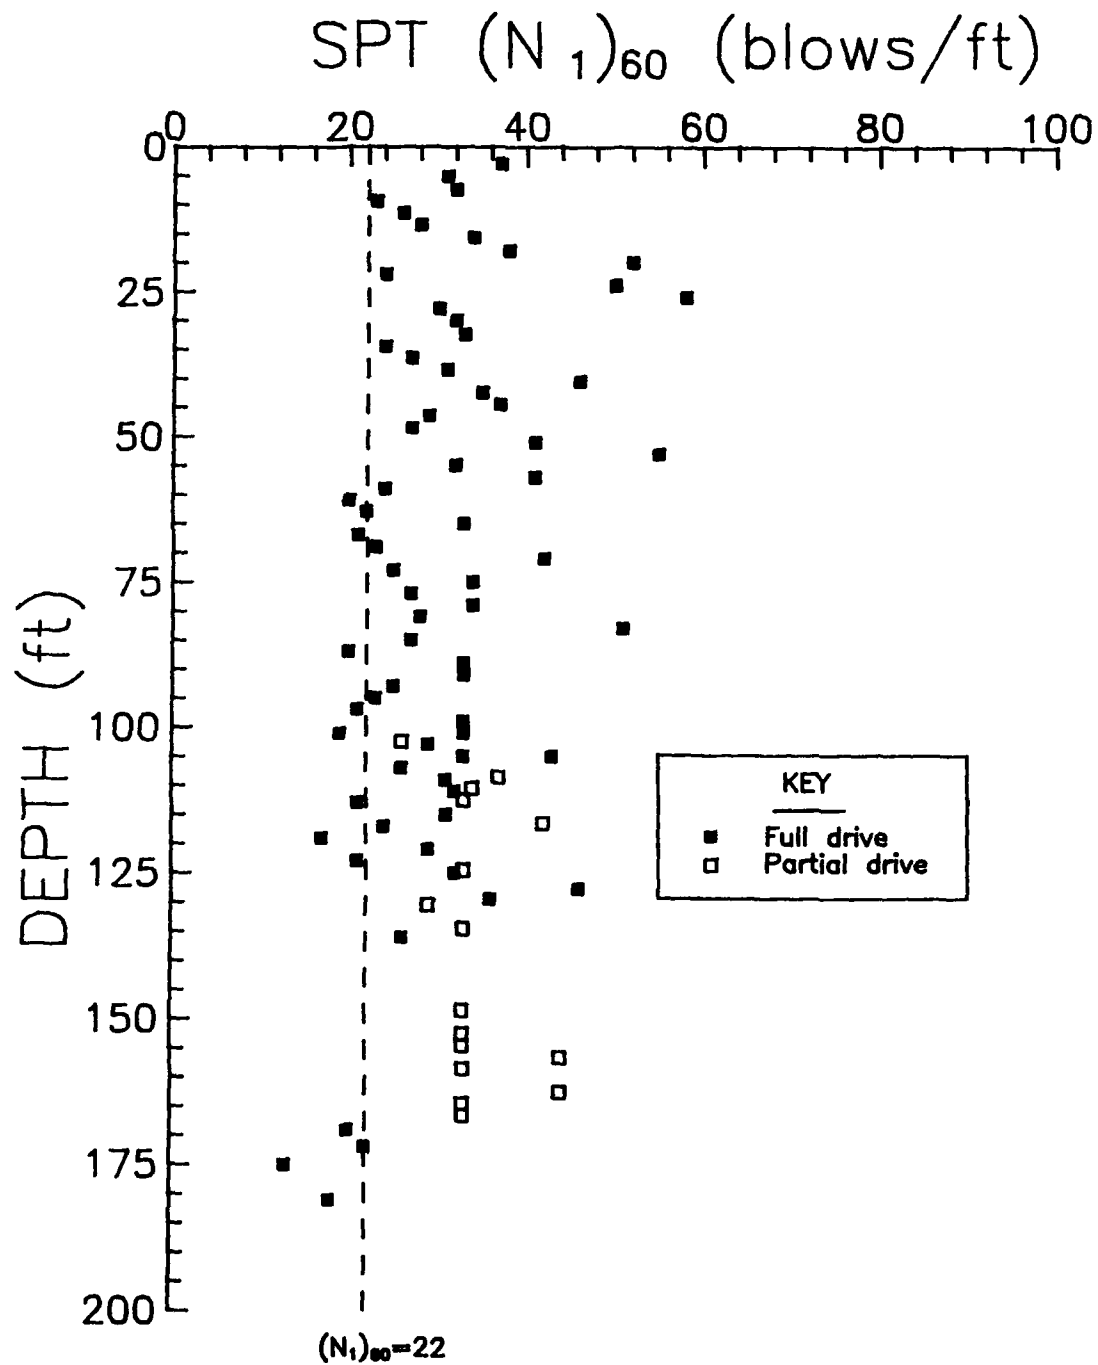
Figure 55. Results of Standard Penetration tests at RWD interface zone modified to represent an equivalent energy of 60 percent and an effective overburden stress of 1 tsf

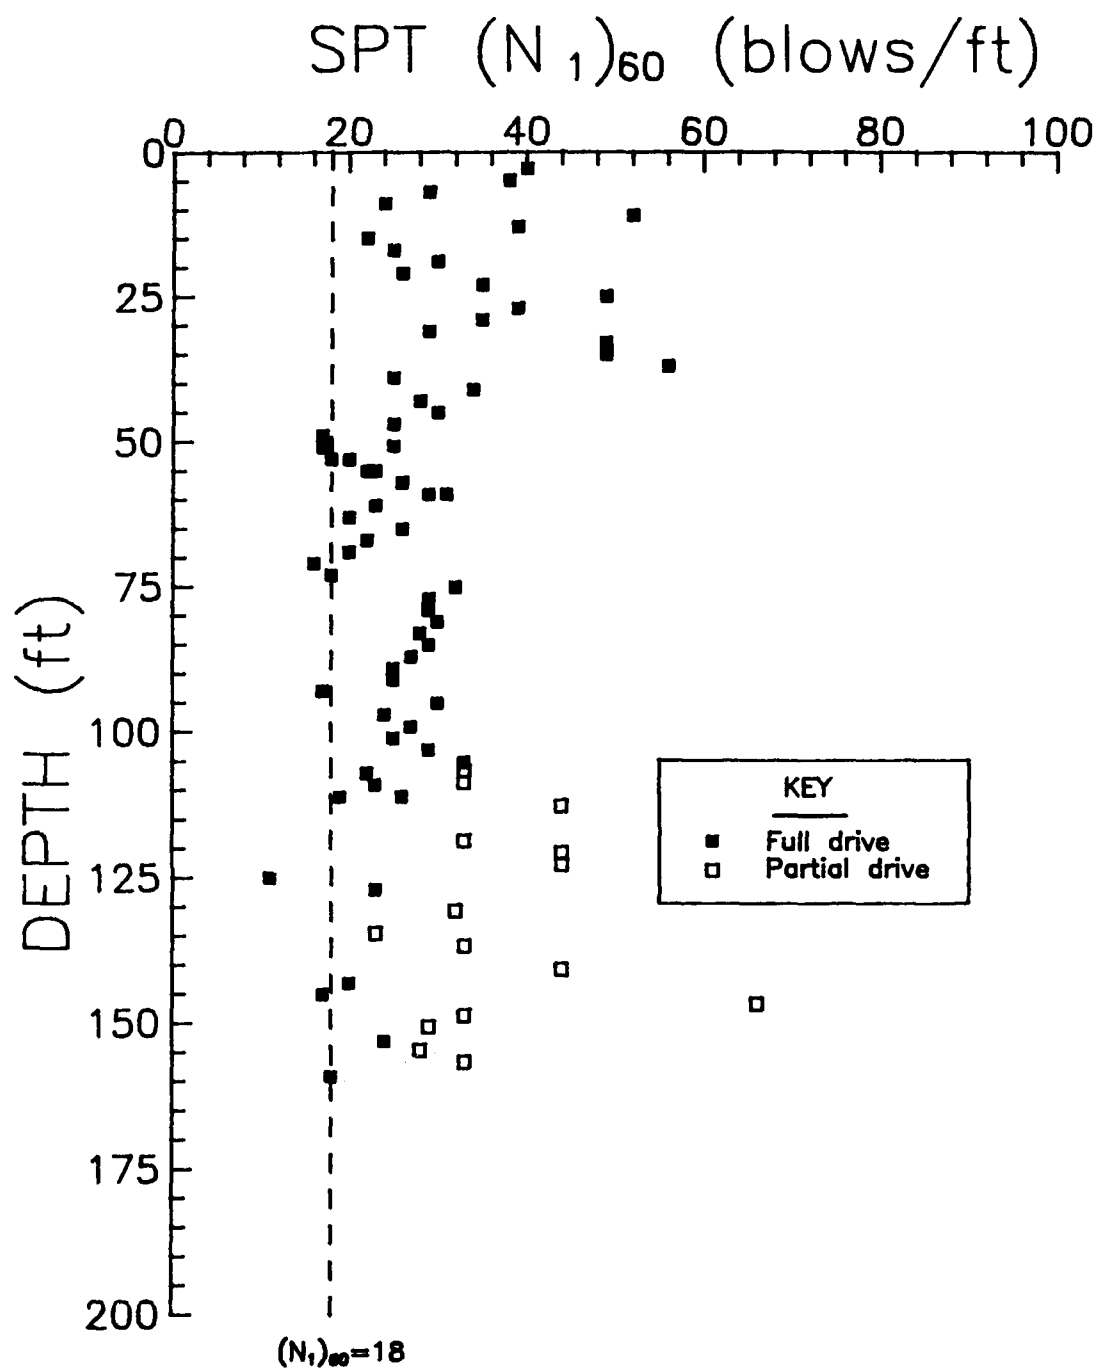
Figure 56. Results of Standard Penetration tests at LWD interface zone modified to represent an equivalent energy of 60 percent and an effective overburden stress of 1 tsf

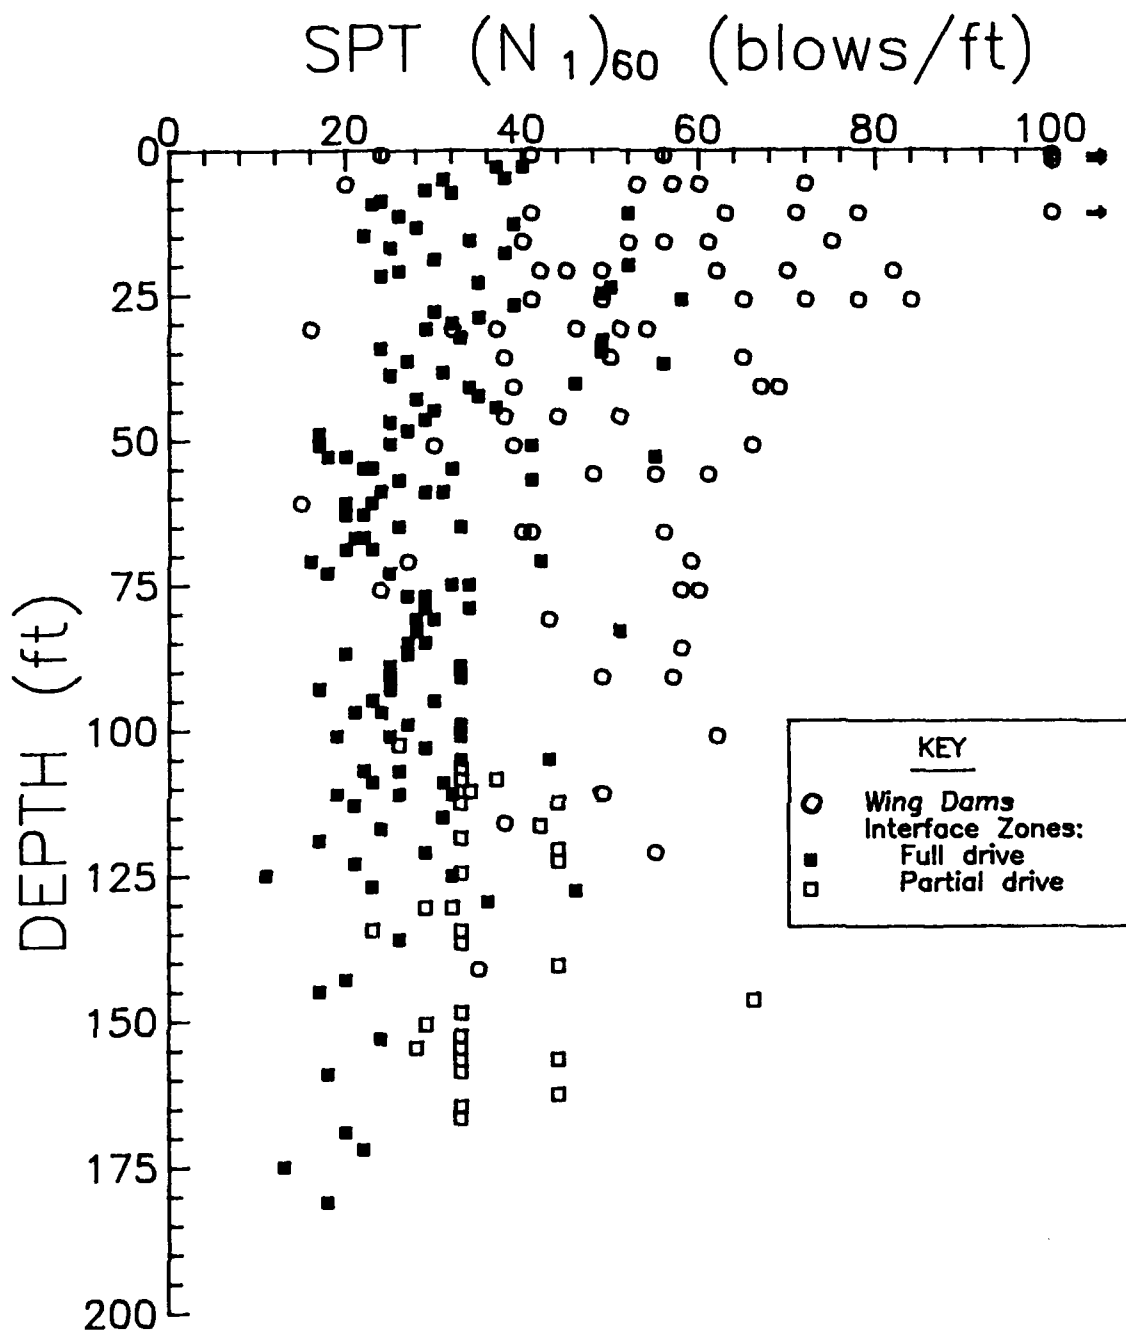
Figure 57. Comparison of ( $N_1$ )<sub>60</sub> for SPT's performed at interface zones and other wing dam locations

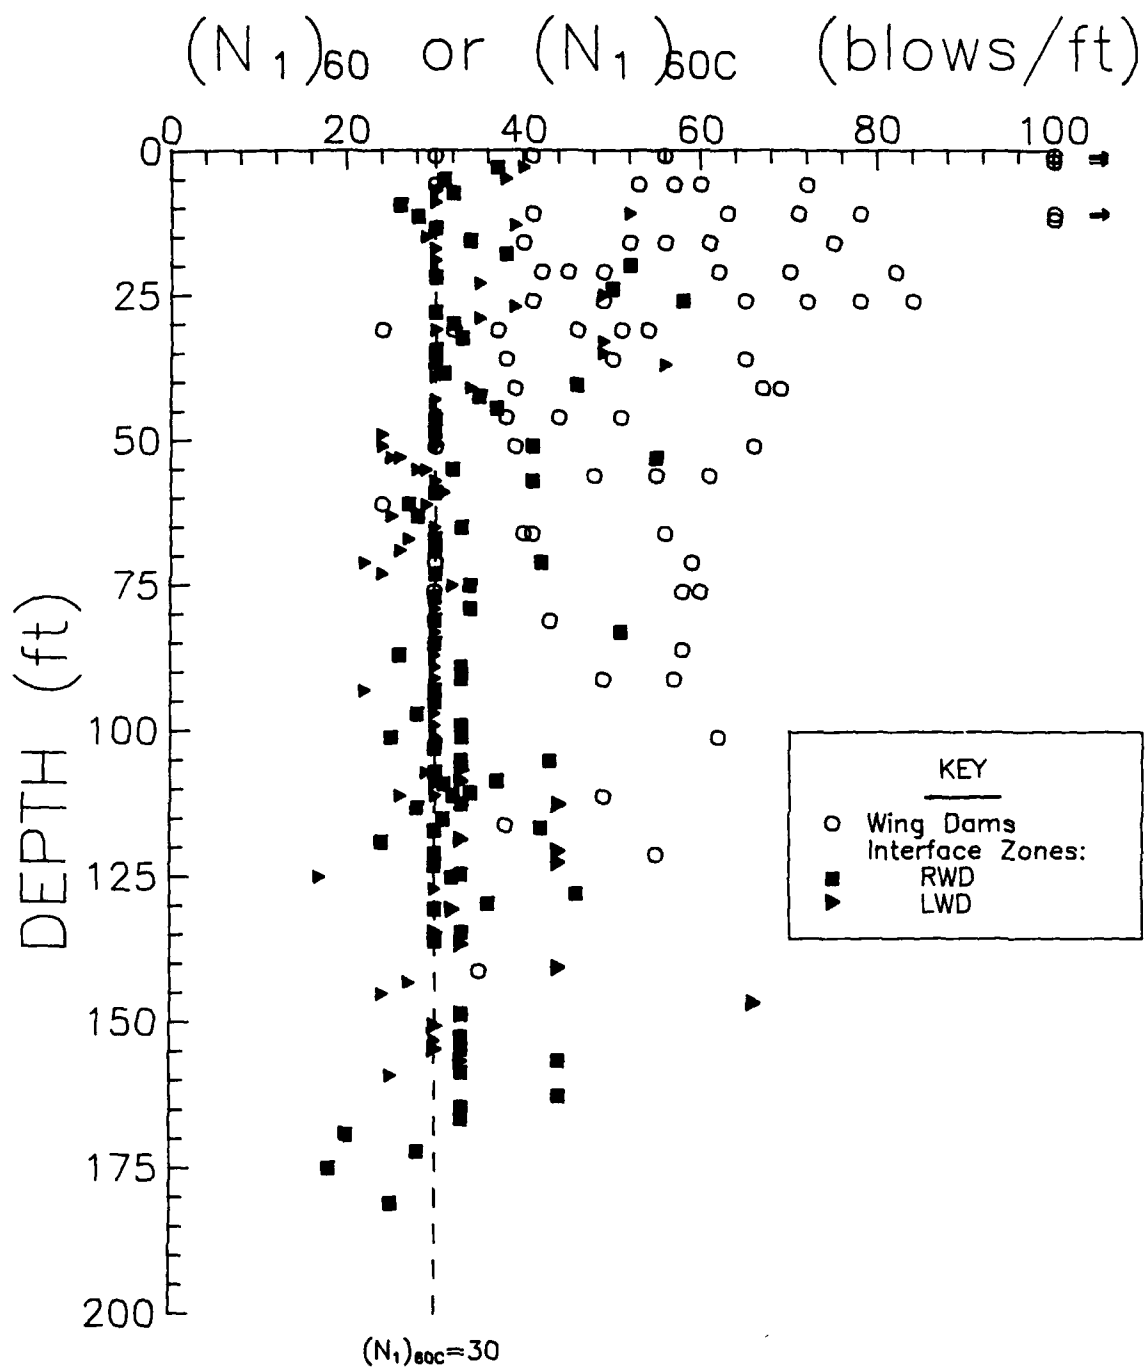
Figure 58. Comparison of  $(N_1)_{60c}$  for SPT's performed at interface zones and other Wing Dam locations

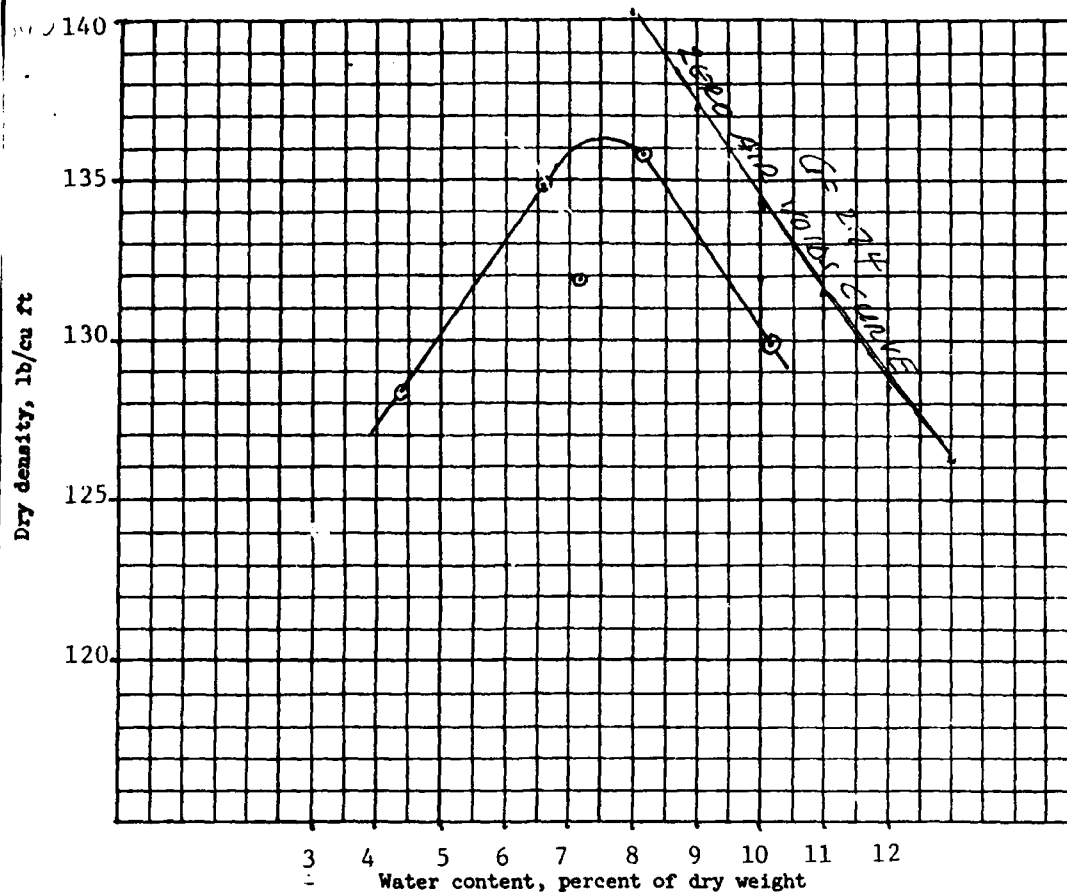
PLATE 74

Modified \_\_\_\_\_ compaction test

\_\_\_\_\_ 25 \_\_\_\_\_ blows per each of \_\_\_\_\_ 5 \_\_\_\_\_ layers, with \_\_\_\_\_ 10 \_\_\_\_\_ lb rammer and  
 \_\_\_\_\_ 18 \_\_\_\_\_ inch drop. \_\_\_\_\_ 4 \_\_\_\_\_ inch diameter mold

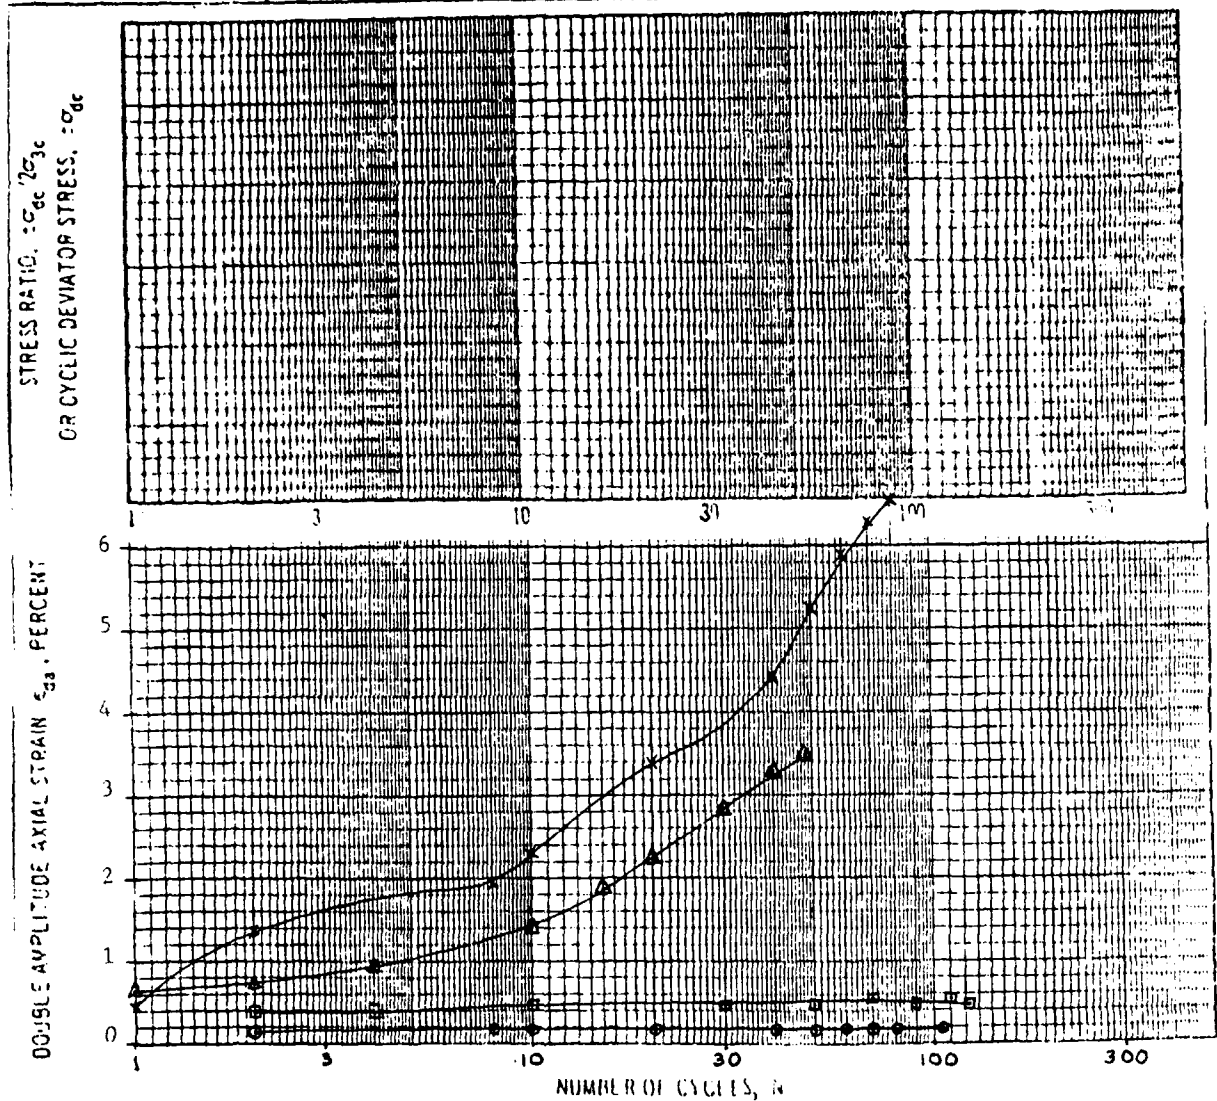
PLATE 75

CYCLIC TRIAXIAL TEST REPORT		Date January 1986
Project Folsom Dam - Left Wing Dam	Boring No. L-1 & L-2	
Sample No. 5, 6, 10, 17	Method of Specimen Preparation undisturbed

SPECIMEN NO.	DENSITY	RELATIVE DENSITY	R	$\bar{\sigma}_{3c}$	CONSOLIDATION RATIO $K_c$	$\sigma_{dc}$	$\sigma_{dc}/2\bar{\sigma}_{3c}$	NUMBER OF CYCLES, N							
								PERCENT PORE PRESSURE INCREASE				PERCENT STRAIN, $\epsilon_{da}$			
								$N_{25\%}$	$N_{50\%}$	$N_{75\%}$	$N_1$	N	N	N	N
87200	123.2	○	.95	1.0	1.0	0.44	0.22	70	-	-	-	-	-	-	-
87201	119.5	△	.95	1.0	1.0	1.01	0.51	1/2-	5	-	-	4.5	17	78	
87205	126.4	□	.96	2.0	1.0	0.92	0.23	1	49	-	-	-	-	-	-
87257	125.5	X	.97	4.0	1.0	1.71	0.21	1	5	11	-	1.5	8	33

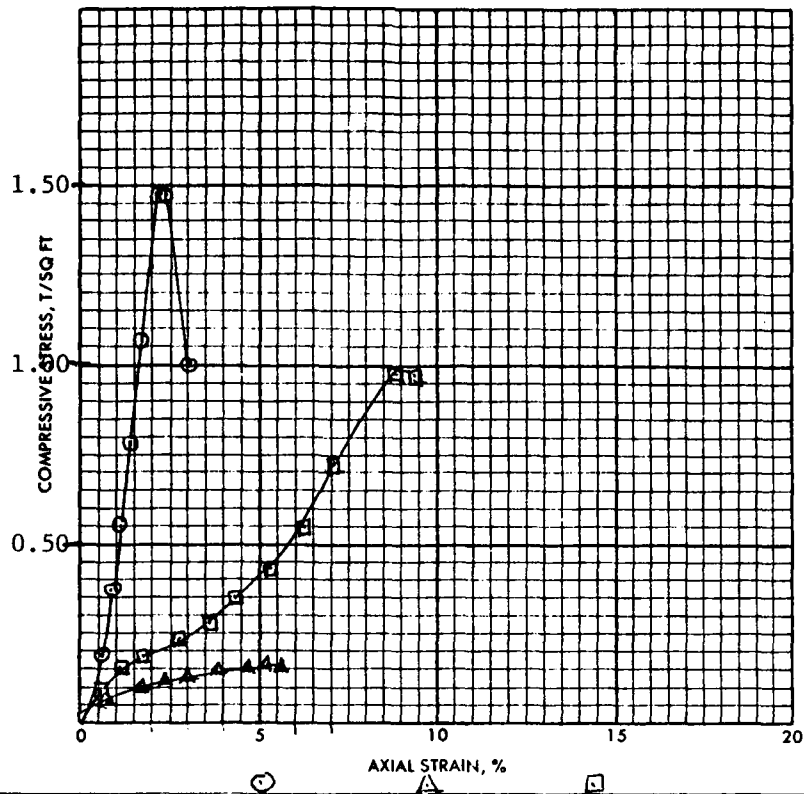
# FAILURE SKETCHES

TEST NO.		L-1, FS 14	L-2, FS 5	L-2, FS 18	
TYPE OF SPECIMEN		Undist.	Undist.	Undist.	
INITIAL	WATER CONTENT	$w_o$	8.5 %	10.4 %	10.9 %
	VOID RATIO	$e_o$	0.343	0.423	0.432
	SATURATION	$S_u$	69 %	67 %	69 %
	DRY DENSITY, LB/CU FT	$\gamma_d$	130.1	119.7	120.3
TIME TO FAILURE, MIN		$t_f$	5.25	7.5	10
UNCONFINED COMPRESSIVE STRENGTH, T/SQ FT		$q_u$	1.49	0.16	1.00
UNDRAINED SHEAR STRENGTH, T/SQ FT		$s_u$	0.74	0.08	0.50
SENSITIVITY RATIO		$S_t$	-	-	-
INITIAL SPECIMEN DIAMETER, IN		$D_o$	2.85	2.85	2.83
INITIAL SPECIMEN HEIGHT, IN.		$H_o$	6.35	6.38	6.20
CLASSIFICATION		<input checked="" type="checkbox"/> Silty Sand (SM)	<input checked="" type="checkbox"/> Silty Sand (SM)	<input type="checkbox"/> Clayey Sand (SC)	
LL -, 24, 28		PI -, 22, 19	PI NP, 2, 9	G, 2.80, 2.73, 2.76	
REMARKS		PROJECT FOLSOM DAM			
Div. No. Hole Depth, ft.		AREA Left Wing Dam			
<input checked="" type="checkbox"/> 87209 L-1 34.0-36.6		BORING NO.		SAMPLE NO.

<input checked="" type="checkbox"/> 87215 L-2 54.6-57.9		DEPTH EL		DATE June 1984	
<input checked="" type="checkbox"/> 82258 L-2 89.6-92.3		UNCONFINED COMPRESSION TEST REPORT
